# TECHNICAL NOTE

## D-442

A PRELIMINARY INVESTIGATION ON THE DESTRUCTION  
OF SOLID-PROPELLANT ROCKET MOTORS BY  
IMPACT FROM SMALL PARTICLES

By David J. Carter, Jr.

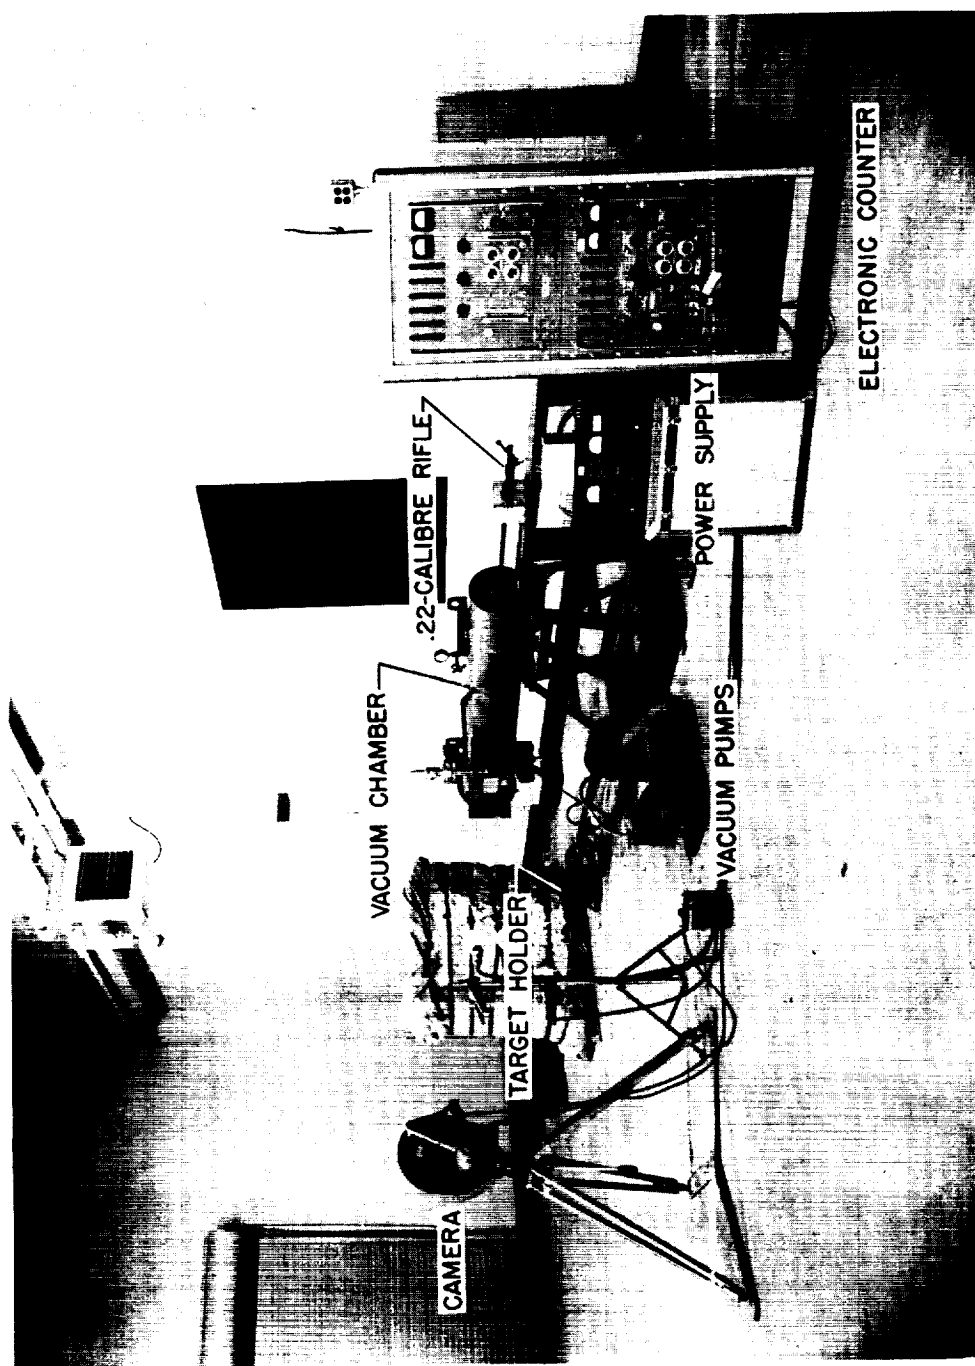
Figure 1.- Overall view of .22-caliber Swift rifle and small vacuum chamber with related equipment.

Two .22-caliber Swift rifles and a helium gas gun were used in this investigation to fire spherical projectiles into simulated-rocket-motor targets. One of the rifles was mounted on a stand and used for atmospheric tests, whereas the other rifle was assembled so that the muzzle extended a few inches inside a small vacuum chamber and fired into targets located at the other end of the chamber; an overall view of this facility is shown in figure 1. The maximum velocity obtained with this facility was 7,800 feet per second. In order to achieve higher velocities a helium gas gun mounted to a large vacuum chamber was used; a photograph of this facility is shown in figure 2. A description of the operation of the helium gas gun is given in reference 1. Velocities on the order of 10,000 feet per second were readily achieved.

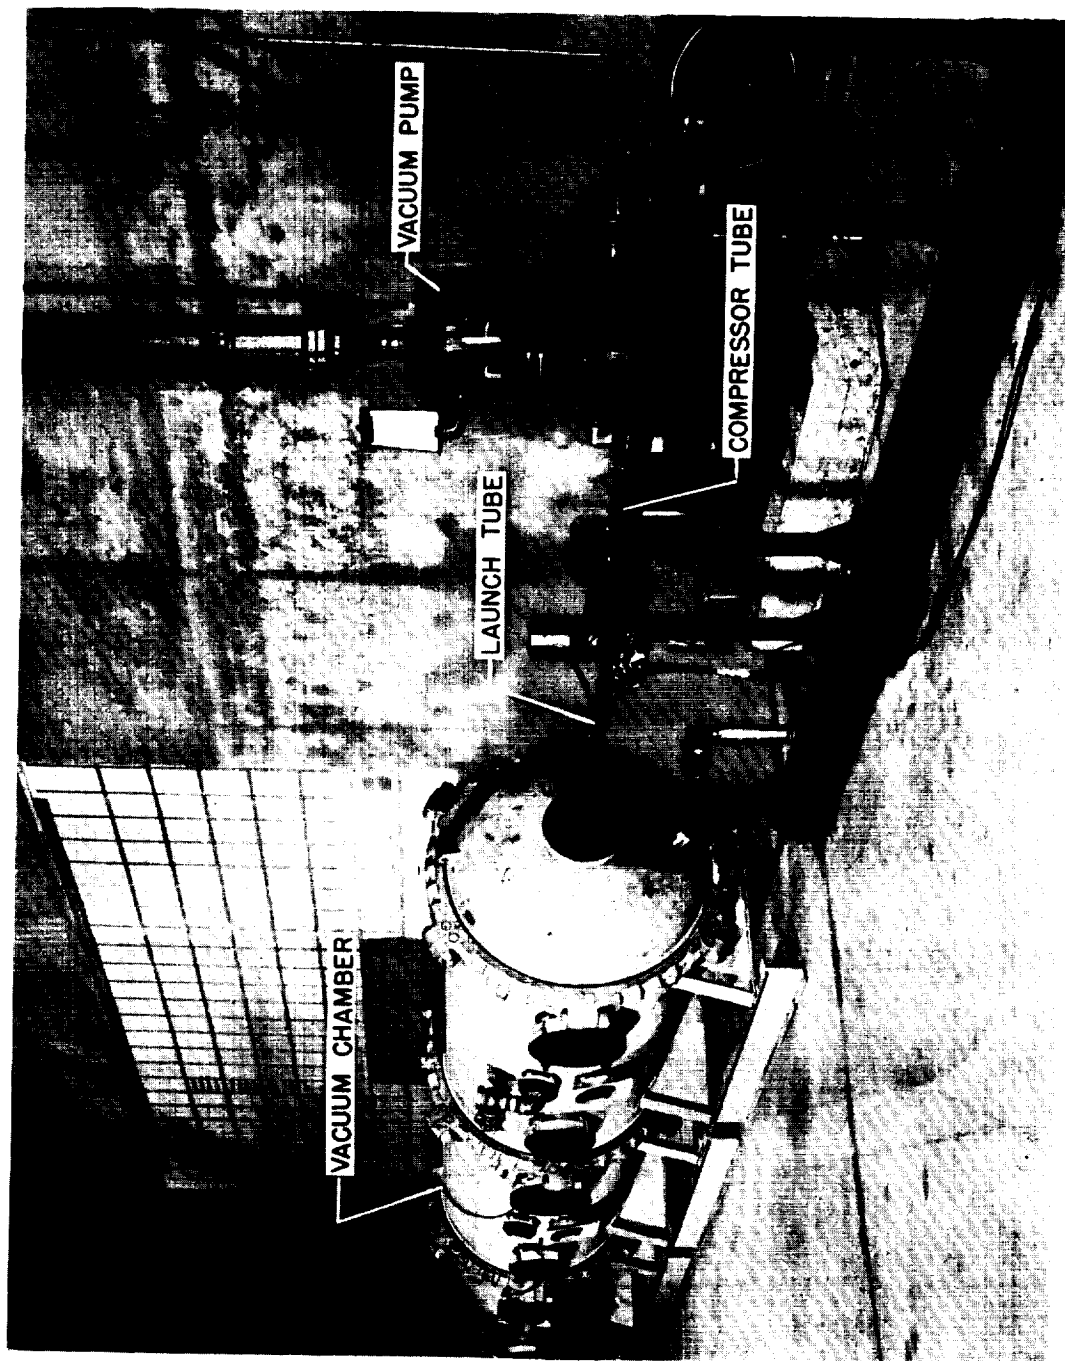
Figure 2.- View of the helium-gas-gun facility with large vacuum chamber.

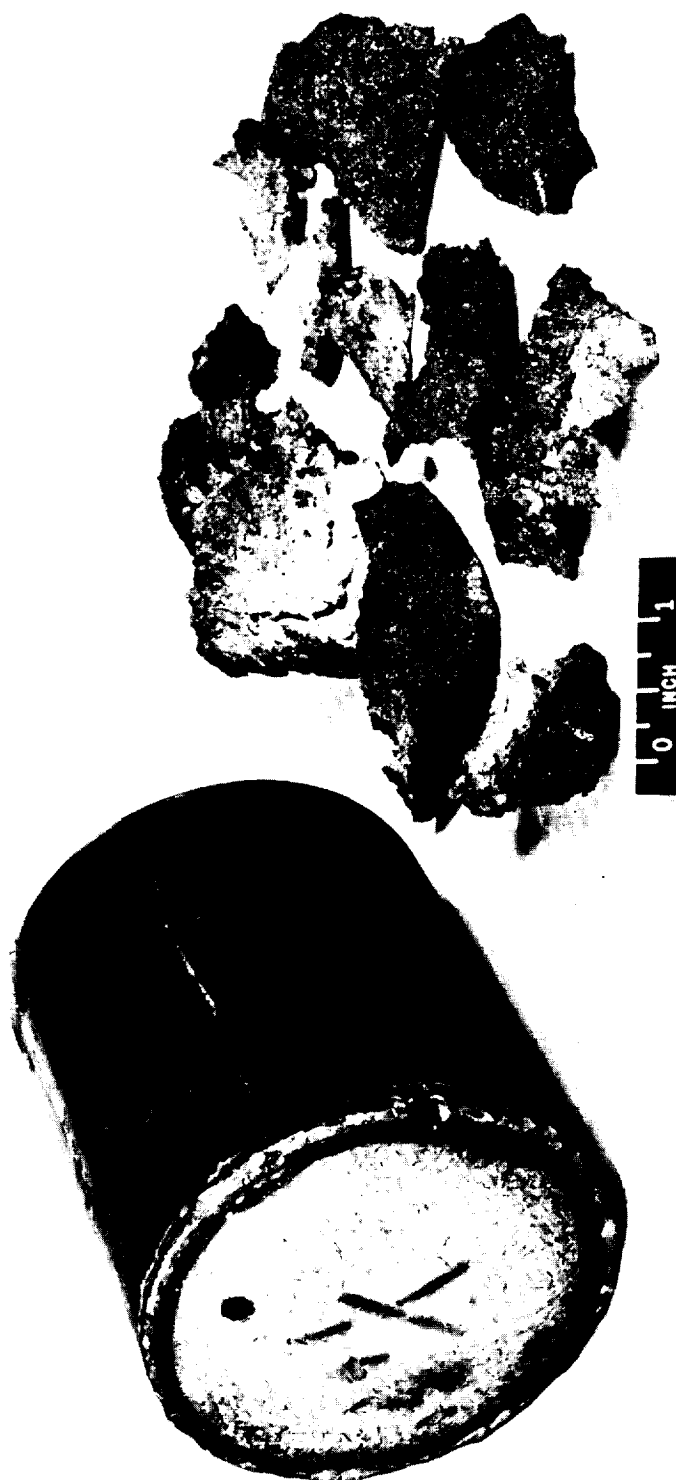
L-59-3109  
Figure 12.- Photograph of grain fragments after impact of a 1/16-inch-plate cylindrical target  
by a 1/8-inch steel sphere. Firing 30.

Class 4 represents impacts resulting in immediate destruction. The impacting particle penetrates a substantial distance into the propellant so that sustained burning results. The pressure may drop after initial burning consumes the irregular surface layer, but it does not drop below the critical level. Since the surface burns radially outward generating increasing areas, the combustion pressure likewise increases. For an actual rocket, class 4 impacts will result in excessive pressures causing the motor to explode. Results of this nature were demonstrated by firings 29 to 31 and are illustrated in figures 9 to 12.
